● Dr. Radu Baston ●

Patient no. 2

Single Tooth Replacement 36

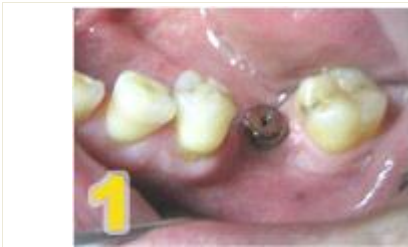
Closed-tray Impression technique
= "pop-in" = "reposition"
technique"

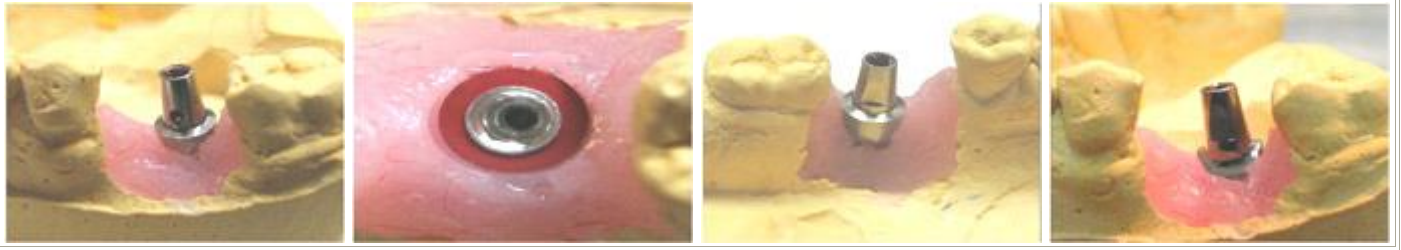
Adjusting the abutment shoulder on the master cast

INITIAL BUCCAL VIEW

INITIAL OCCLUSAL VIEW

FINAL LINGUAL VIEW

FINAL BUCCAL VIEW

THE LINGUAL ASPECT OF THE SHOULDER HAS RETAINED ITS ORIGINAL SHAPE

THE BUCCAL SHOULDER HAS BEEN MODIFIED

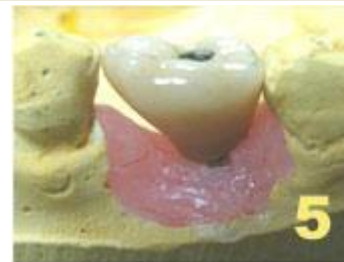
5

The crown is cured directly on the abutment for cemented superstructures

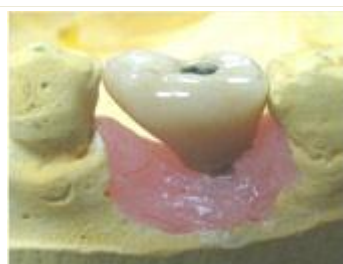
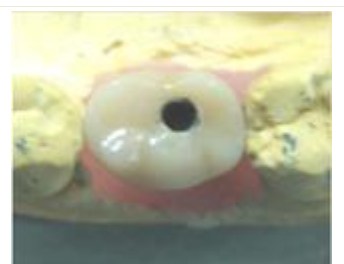
The crown design: no gap, no cementation, customized slanted step, screw-retained.

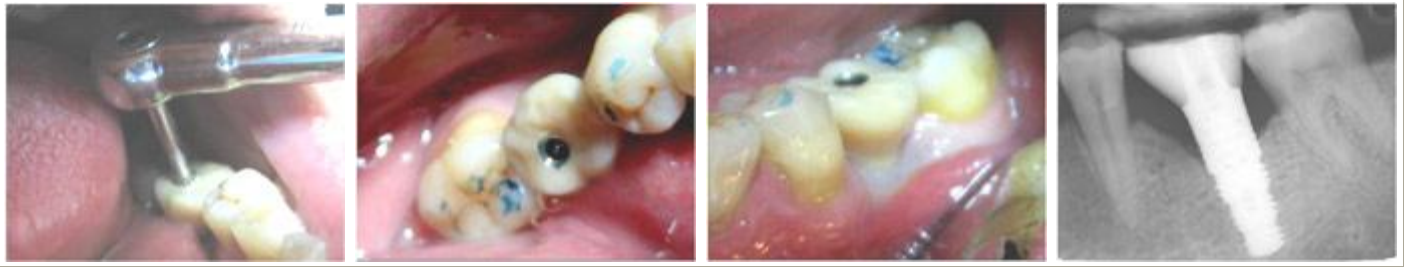
Crown fastening and final result
